# Manhole Inspection Summary

Manhole # S01EE2016MH

Insp Date: **7/24/06 8:03 AM**

**Location** Address: **3301 BANCROFT RD**

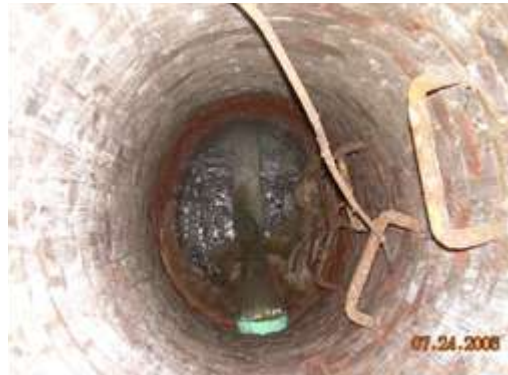
Top View

**Steps** Count: **8** Missing: **0** ☒ **Corroded**

Corroded steps.

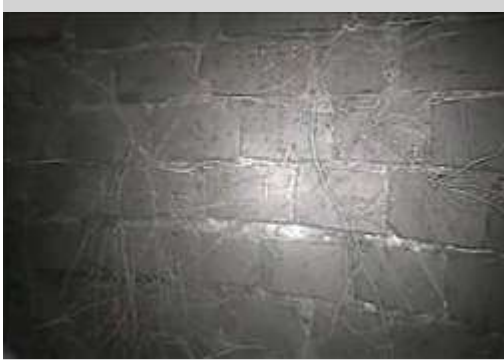
Defect

Condition: ☐ Sound ☐ Cracked ☒ **Root Intrusion** ☐ Loose Brick ☐ Deteriorated

Corbel root intrusion.

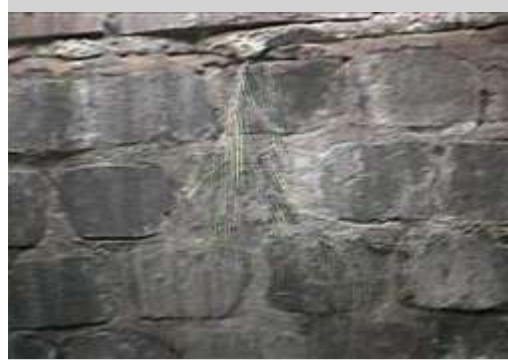
Defect

Condition: ☐ Sound ☐ Cracked ☒ **Root Intrusion** ☐ Loose Brick ☐ Deteriorated

Infiltration: ☐ None ☒ **Joint** ☐ Cracks ☐ Mortar ☒ **Roots** ☐ Wall

Adjustment root intrusion and infiltration.

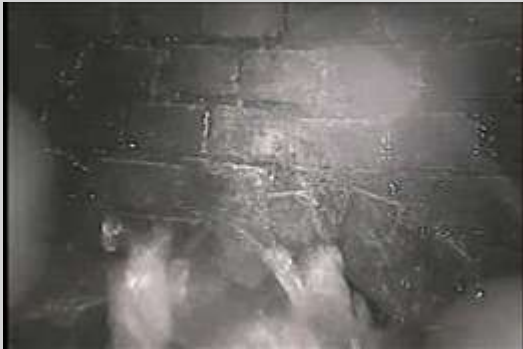
### 8 in. Circular Gravity Sewer Pipe Out @ 12 O'Clock

Infiltration: **None** Pipe Seal Cond: **Roots**

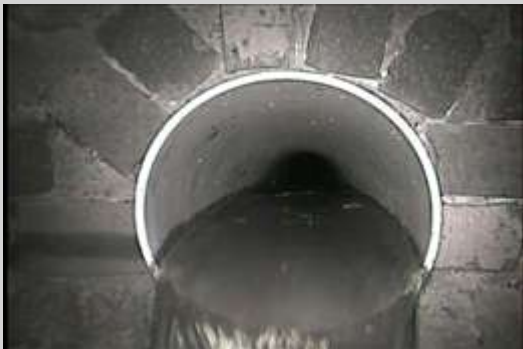
### 8 in. Circular Gravity Sewer Pipe In @ 6 O'Clock

Deposits: ☐ None ☒ **Mud** ☐ Sludge ☒ **Debris** ☐ Grease

Silt Depth: **3** (in.) Deposits Extent: **Medium**

Infiltration: **None** Pipe Seal Cond: **Roots**

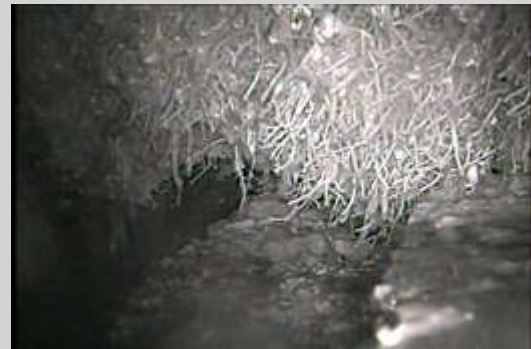
### Drop In @ 6 O'Clock

Barrel root intrusion.

Drop Condition: **Clogged**
